# **ELECTRODEPOSITION OF WEAR RESISTANT COATINGS**

**April 1990**

**Final Report**

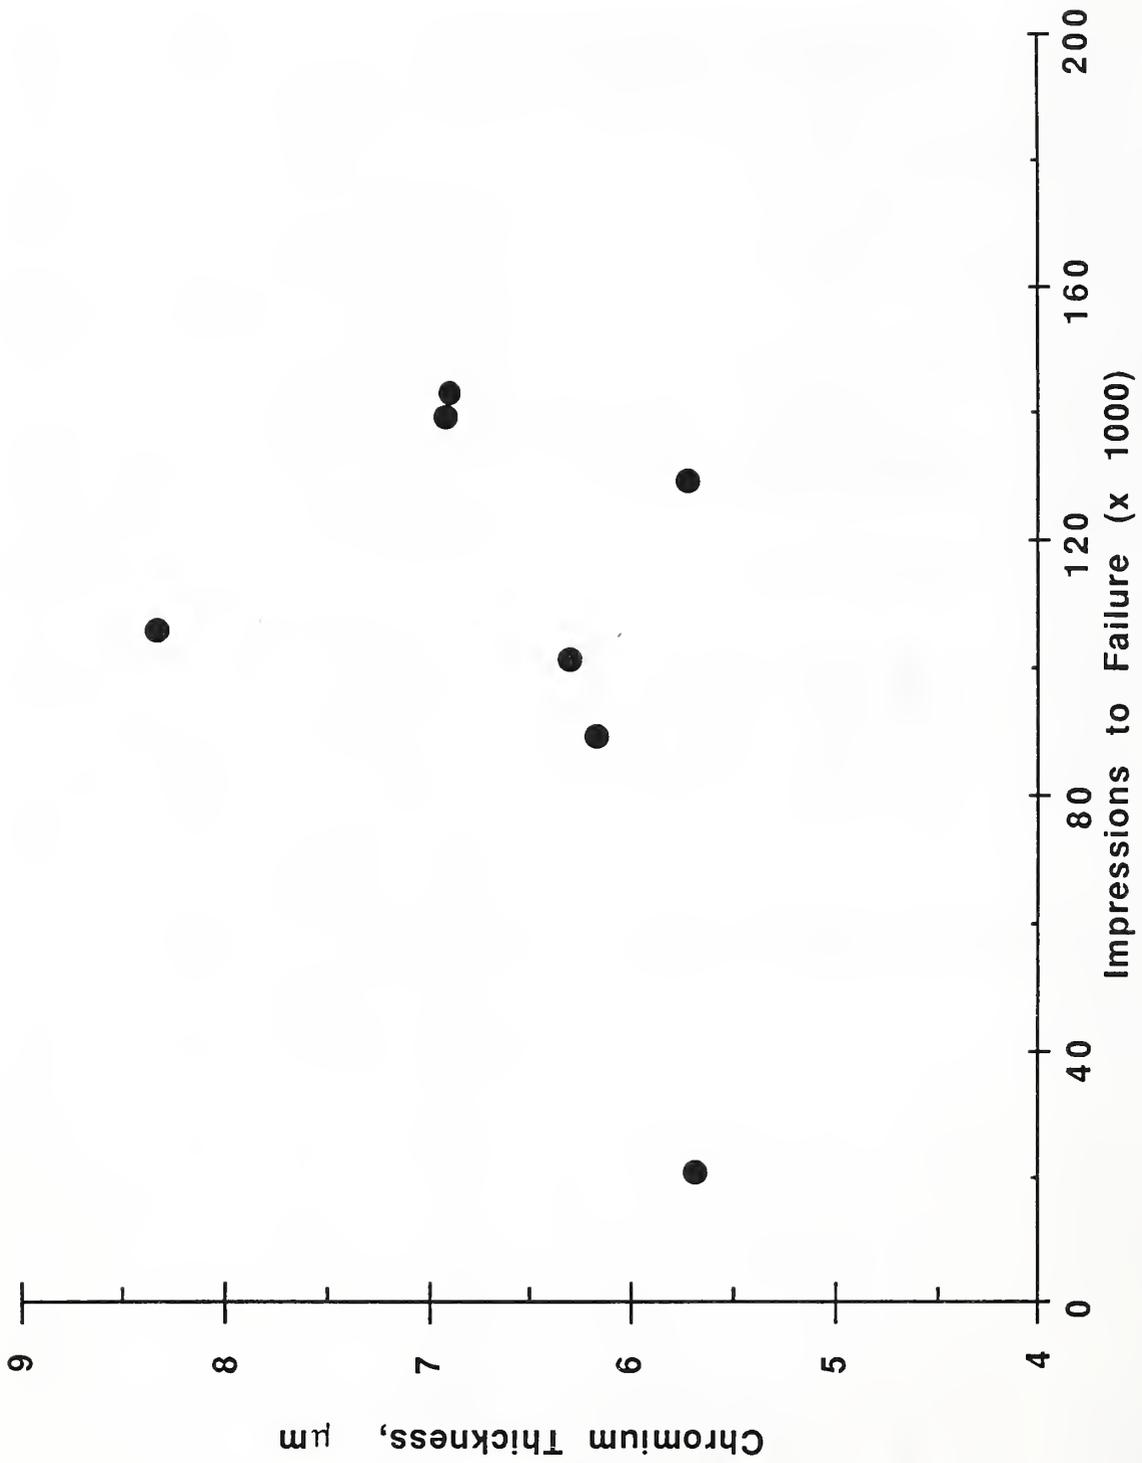
Figure 1. Number of impressions to failure of engraved printing plates (face plates only) as a function of chromium thickness.

In order to accurately correlate wear performance (number of impressions to failure) with a coating property, data can only be obtained from similar plates used on the same type presses for example all "faces" on "paper wipe" presses. Accordingly, face plates were supplied by BEP with accompanying data for the number of impressions made with each plate before failure, Table 2. The plates were of the same denomination and were run on the same press. Chromium thickness was determined for each plate using the Kocour test, Table 2. No correlation could be made with chromium thickness and number of impressions to failure, Figure 1. Results from other studies on engraved printing plates indicated that chromium thickness less than 0.20 mil ( $5.08 \mu\text{m}$ ) resulted in a low number of impressions to failure, whereas the number of impressions to failure seemed to level out at chromium thicknesses of 0.25 mil ( $6.35 \mu\text{m}$ ) and greater.

- o There was no correlation between chromium thickness and number of impressions to failure with chromium thicker than 0.25 mil (6.3  $\mu\text{m}$ ).

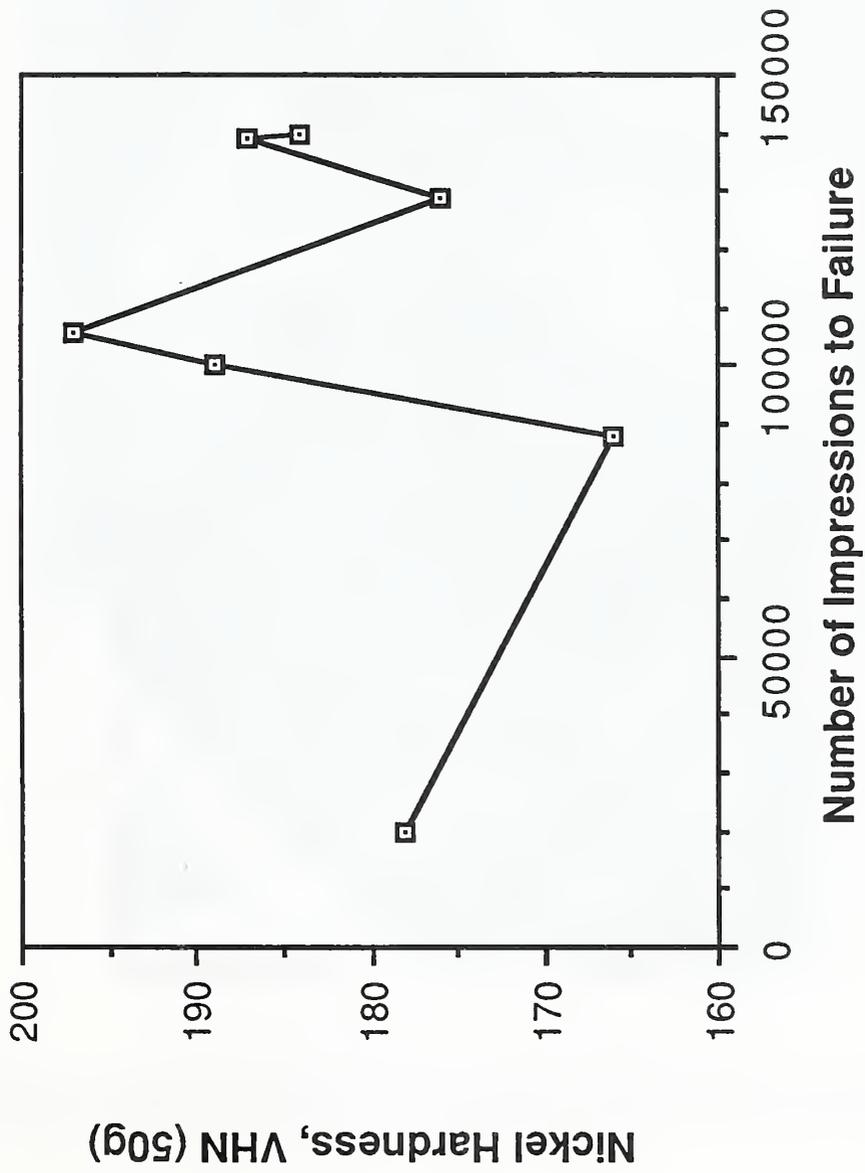
Figure 2. Number of impressions to failure of engraved printing plates (face plates only) as a function of nickel microhardness determined at a load of 0.49 N (50 g-f).

- o There was no correlation between hardness of nickel and number of impressions to failure.
- o Uneven wear of engraved lands in color bars was observed, possibly due to the printing plate not being mounted flat in the press.

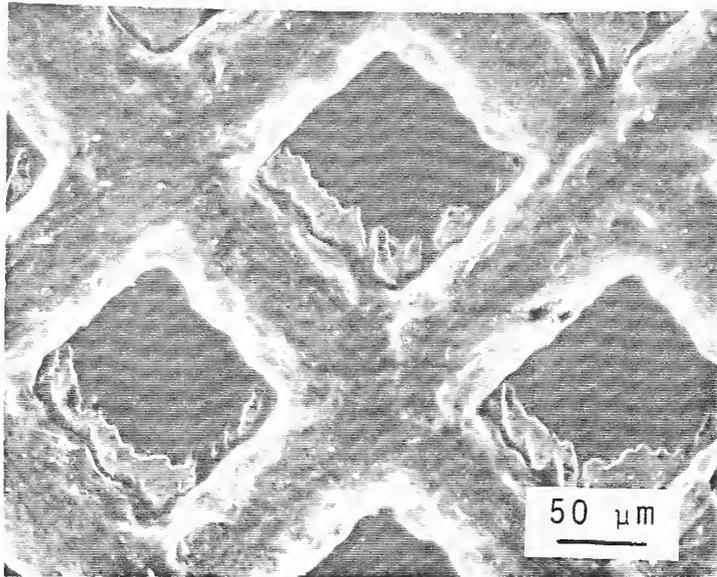
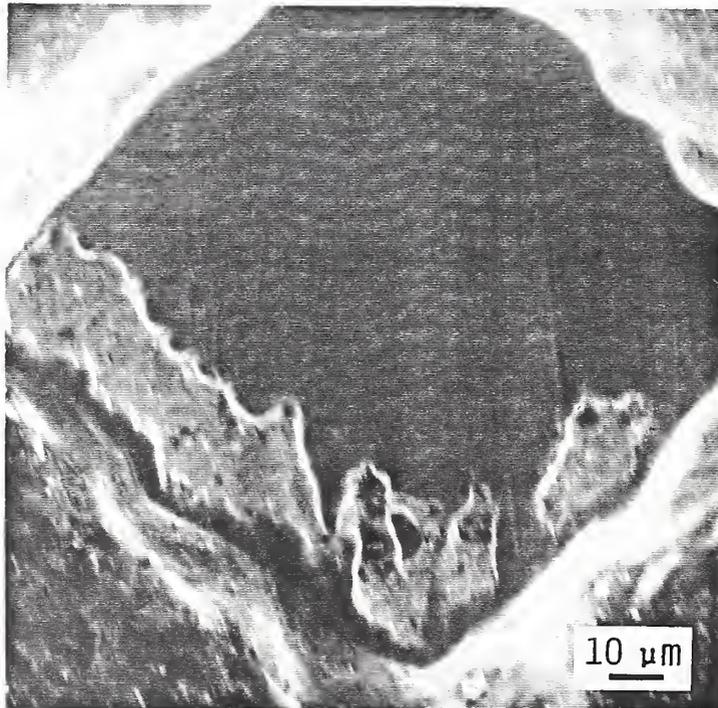
Figure 3. Scanning electron micrographs of chromium wear on an engraved area of a printing plate. Note the uneven wear and patches of chromium left on surface of nickel electroform.

Preliminary scanning electron microscope (SEM) evaluation of color bar wear of an unidentified plate, Figure 3, was done by John Collins of BEP. The photos revealed that some of the peaks or lands were devoid of chromium, whereas others still had areas of chromium remaining. Some of

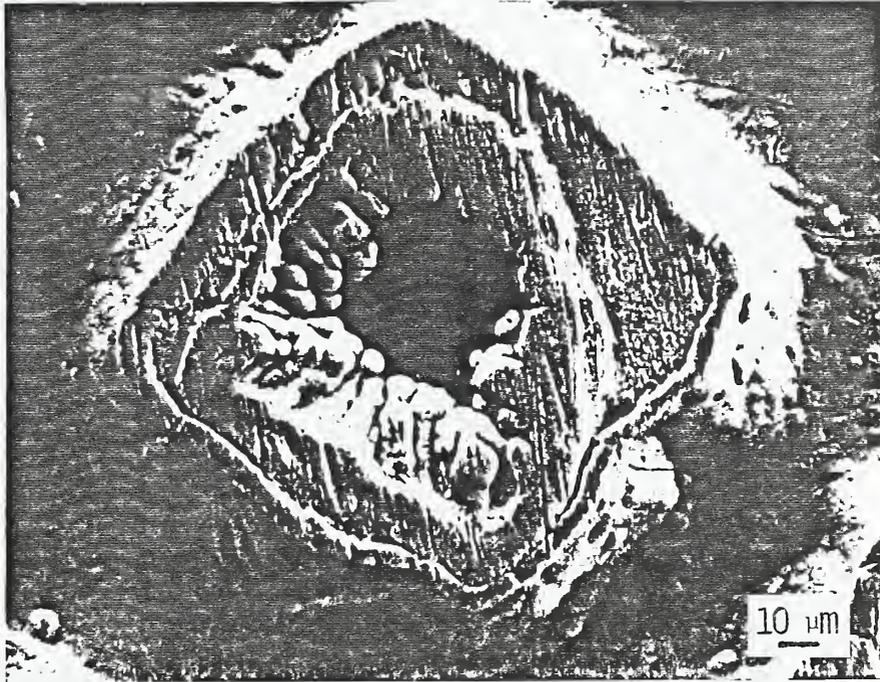
Figure 4. Scanning electron micrograph of modular growth on the engraved land area of a color bar. The modulation may either be in the nickel or chromium.

the lands showed pits or voids that apparently were located in the nickel. Nodular areas around the pits may be a result of either the nickel or chromium deposition, Figure 4. If nickel is causing the problem, this kind of morphology can result when boric acid is low in the nickel electrolyte. If the nodulation is in the chromium, this morphology can result from low sulfate content in the electrolyte or from high localized current densities due to the sharp edge geometry of the engraved areas. SEM photos of the cross-section of the color bar area revealed what appeared to be fatigue cracking in the nickel under the chromium plate, Figure 5. The fatigue cracking and deformation of the nickel seemed more prominent on the edges of the lands.

- o Nodules were observed on the engraved lands of color bars. These may be due to low boric acid content in the nickel electrolyte, if they were nickel nodules. If they were chromium nodules, low sulfate or impurities in the electrolyte could be the cause. Localized high current densities in the engraved areas could also result in nodulation.

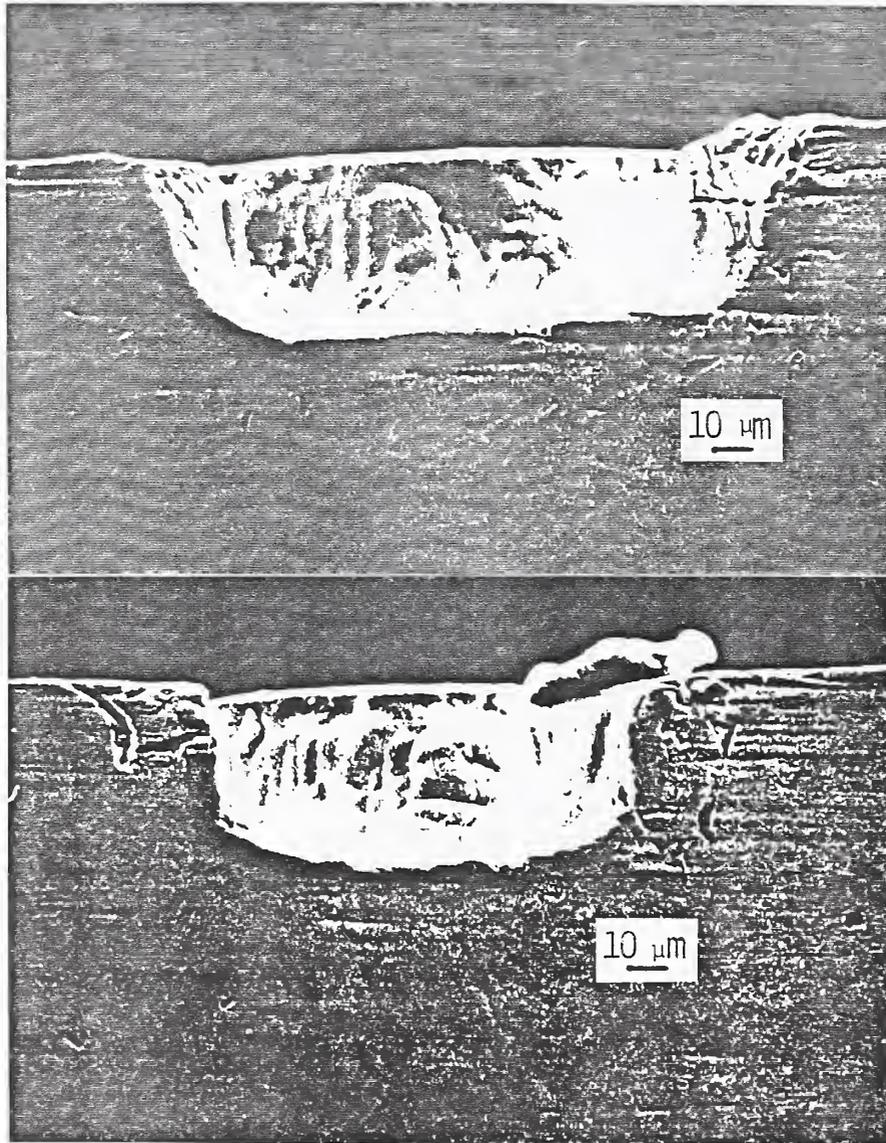
Figure 5. Scanning electron micrograph of a sectioned color bar area of a printing plate revealing the apparent fatigue cracking in the nickel electroform under the chromium plate.

- o SEM and optical photos showed cracking in the nickel just under the chromium in both the engraved and smooth areas of the plate. This is most likely fatigue cracking. Corrosion of nickel was detected which occurred through the microcracks in the chromium.

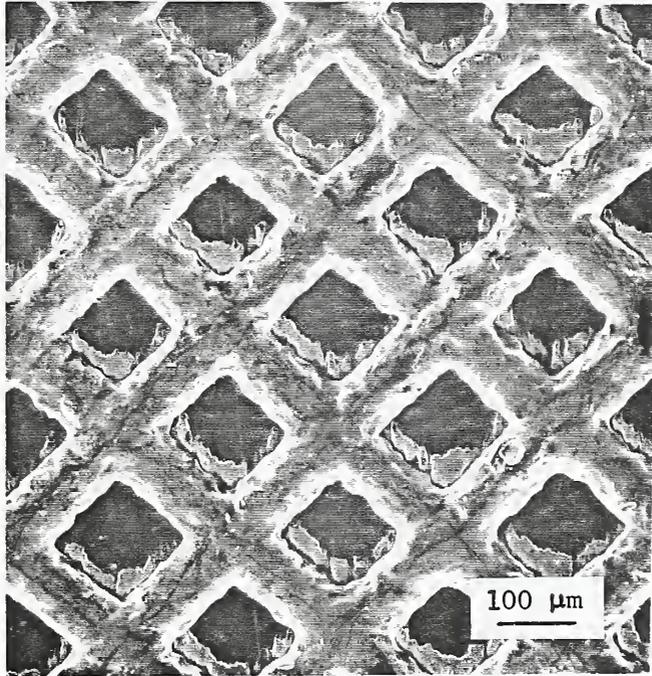
Figure 6. Scanning electron micrograph of color bar area from plate 50265. Number of impressions to failure = 20,000.

across the land with time. This is indicated by the remaining chromium left on some of the lands, Figure 6. This appearance of uneven wear may have resulted from the plate not mounted flat on the press. Pitting of the chromium plate, as well as corrosion products and/or ink residue, were noted in the grooves or valleys of the engraved color bars, Figure 8.

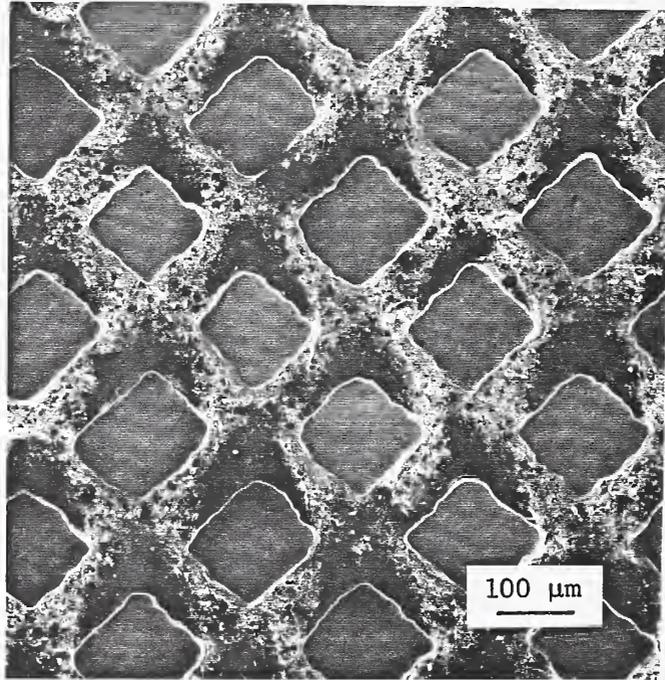
Figure 7. Scanning electron micrograph of color bar area from plate 50264. Number of impressions to failure = 139,000.

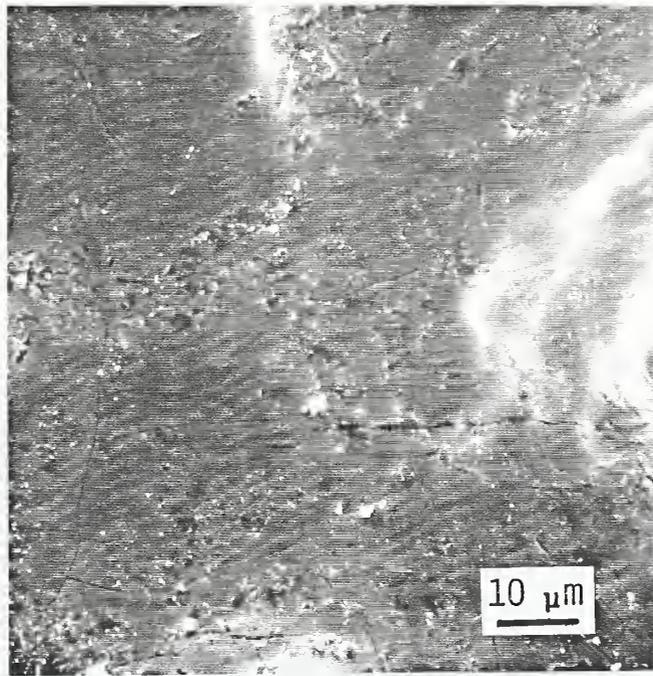
Figure 8. Scanning electron micrographs of grooves or valleys in color bar area from plates 50265 and 50264 revealing the pitting of the chromium and the accumulation of ink residue and/or corrosion products.

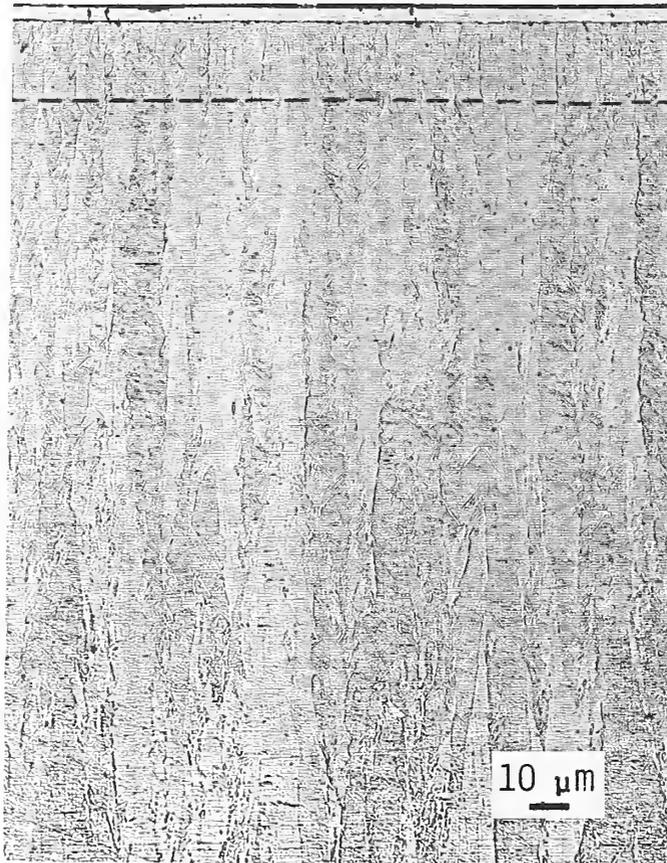
Figure 9. Optical micrograph of polished and etched section of plate 50168 revealing grain structure of the nickel. Note the finer grain size just under the chromium overplate.

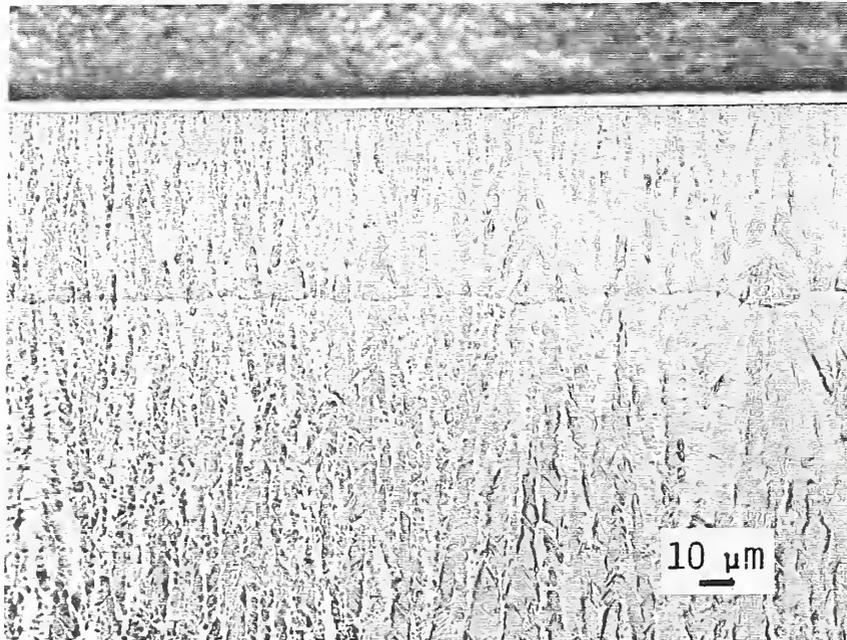
Figure 11. Optical micrograph of polished and etched section of a plate end revealing a boundary line in the nickel electroform indicative of a current interruption.

Several interesting features were noted while evaluating the cross-sections of the plates. A polished and etched section of a plate end revealed that during the course of electrodepositing the nickel, the current was interrupted as indicated by the boundary line (oxide) seen in Figure 11. Even though the structure of the subsequent deposit appeared to be epitaxial, the oxide included at this interface which could

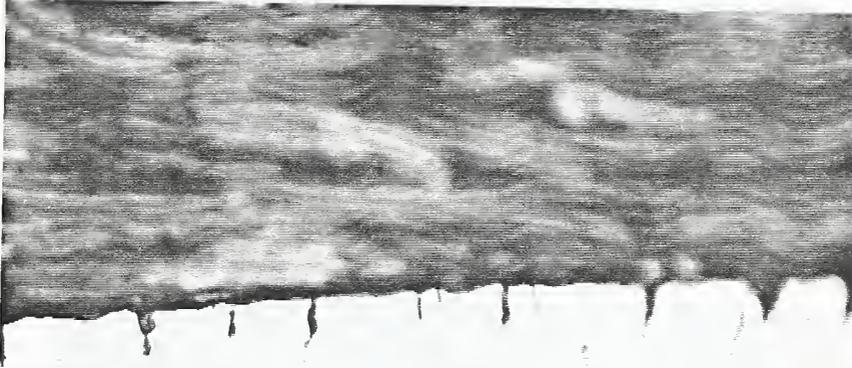
Figure 12. Optical micrograph of a polished section of a plate end revealing the cracking of the nickel at the site of a micro-crack in the chromium.

possibly be a site for delamination of the electroform when subjected to the stresses of printing. Cracking in the nickel was noted just under the chromium overplate, Figure 12. The cracks in the nickel electroform appear to result from the microcracking of the chromium. The cracks in the chromium probably act as stress risers from which the cracks in the nickel initiate. This cracking in the nickel may cause spalling of the chromium overplate or failure due to cracked plates. Another interesting feature was that corrosion of the nickel was occurring through the microcracks in the chromium, Figure 13. This may also be a cause of spalling of the chromium. It appears that the corrosion of the nickel through the microcracks in the chromium is occurring in stressed areas, probably during the various bending procedures of the flat plate or possibly during the printing process when the load is applied and released. These bending or flexing conditions apparently caused the microcracks to open.

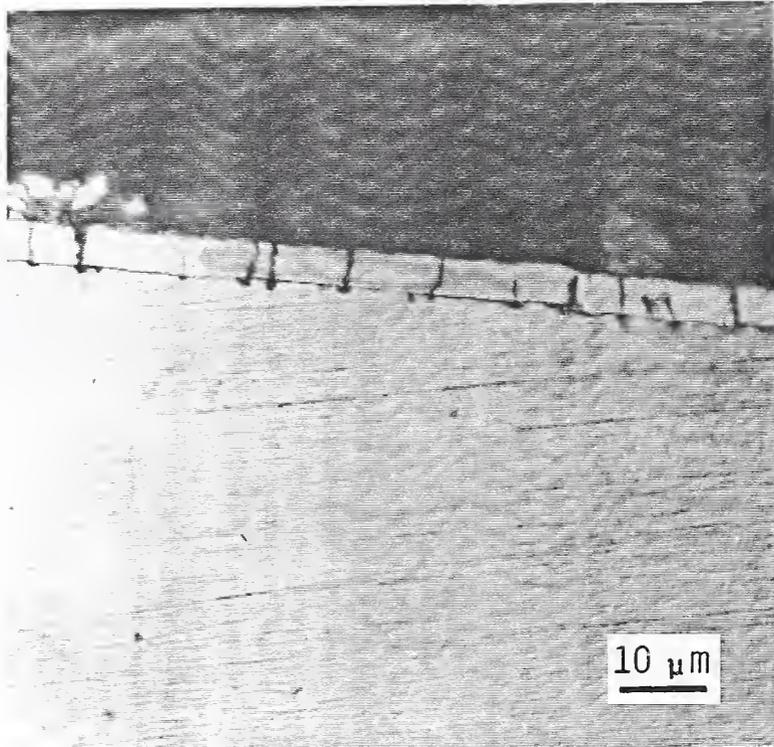
Figure 13. Optical micrograph of a polished and very lightly etched section of the plate end from plate #50264 revealing the corrosion of the nickel occurring through the microcracks in the chromium.

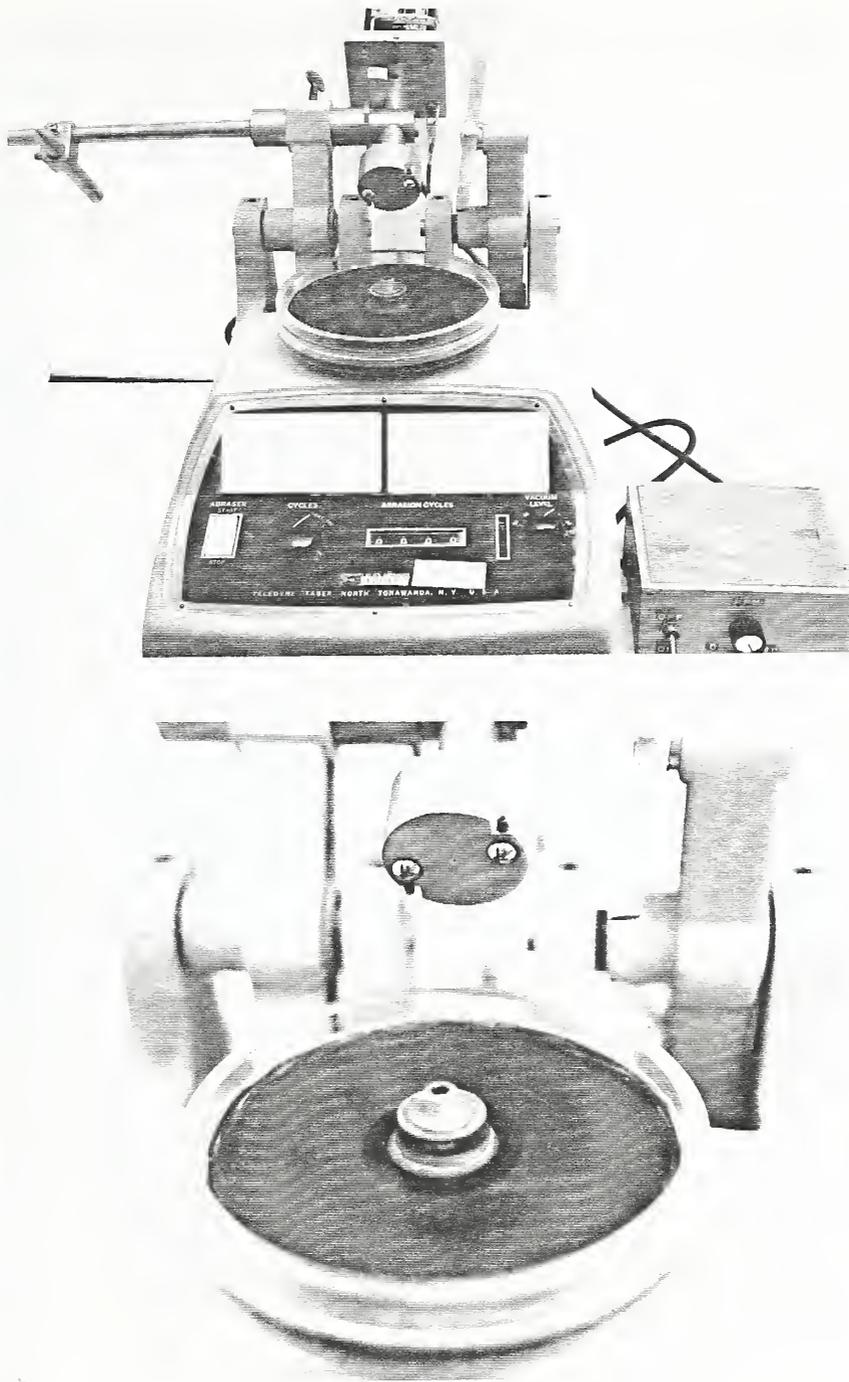
Figure 14. Photos of abrasive slurry wear tester used for the accelerated wear testing of chromium and other metal coatings.

the wear modes associated with the printing process was acquired. The geometry selected is similar to that proposed by NBS for more accurate modeling of the wear conditions. It consists of a pin on disc system with the pin being a 3/8 inch diameter 52100 steel ball bearing pressed with a force of 30.0 N (3100 g-f) against a rotating counterface, Figure 14. The path of the pin on the counter face surface describes a spiral. The surface speed varies from 8.1 to 48 cm/sec. Wear was measured by weight loss of the pin using a microbalance. It should be noted that wear could also be determined by measuring the diameter of the worn spot. The materials selected for the counterface were (1) Viton, (2) PVC, obtained from a portion of printing roller at BEP and (3) 1000 grit silicon carbide paper used without any lubrication. The polymeric counterfaces were used with an abrasive slurry whose composition is given in Table 6. This slurry was chosen to establish abrasive wear conditions using a convenient size and type of abrasive. While the slurry does not duplicate the conditions of service at BEP, it will permit obtaining wear data for use in preliminary ranking of coatings.

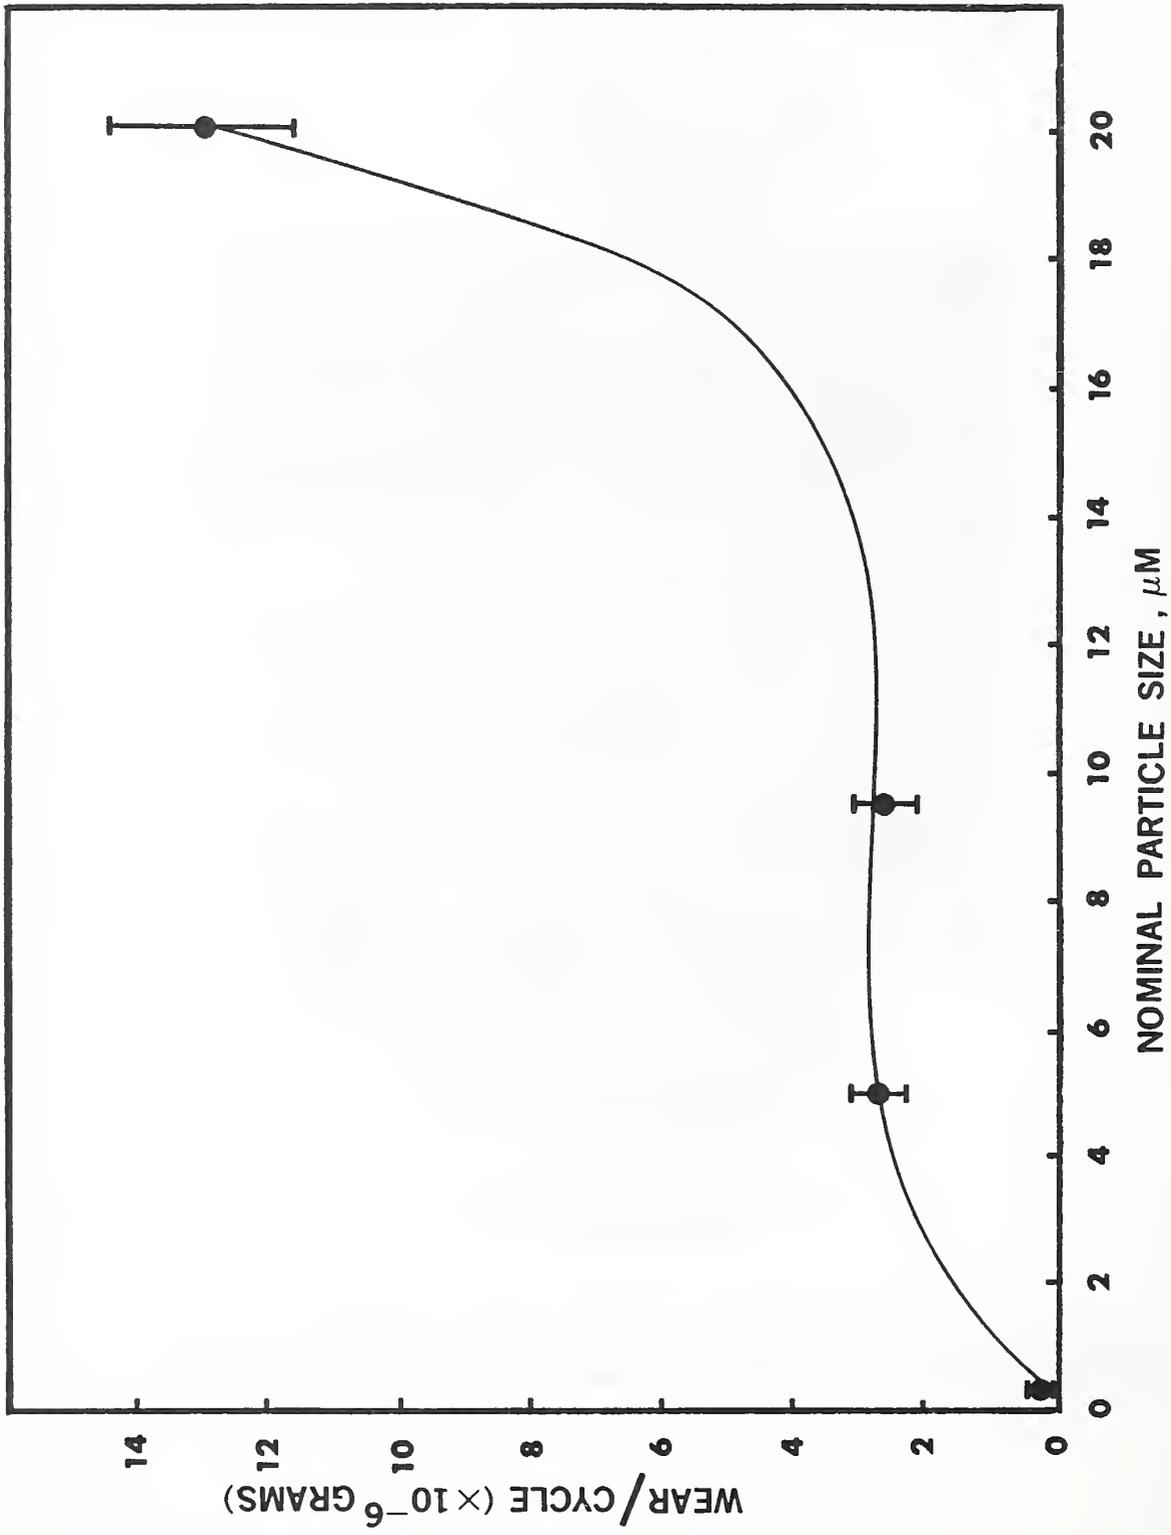
Figure 15. Graph of wear rate of electrodeposited bright nickel vs aluminum oxide particle size used as the abrasive in the accelerated abrasive slurry wear tester.

The preliminary wear test was further evaluated for conformance to abrasive wear experience by studying the effect of abrasive wear particle size on the wear rate of coatings. "Bright" nickel coatings were used as a baseline coating for determining the wear rate vs. particle size dependence. These results are shown in Figure 15. The results indicate that the abrasive slurry wear test is in agreement with prior abrasive wear experience [1]. This experience has shown that wear rate is low when the particle size is small, then increases to a plateau region, then further increases as the particle size becomes large. The BEP-PVC counterface is now used in combination with the abrasive slurry for obtaining preliminary wear data during the coating evaluation process. In connection with printing plate wear, it should be pointed out that by reducing the abrasive particle size, a very significant decrease in wear may be possible.

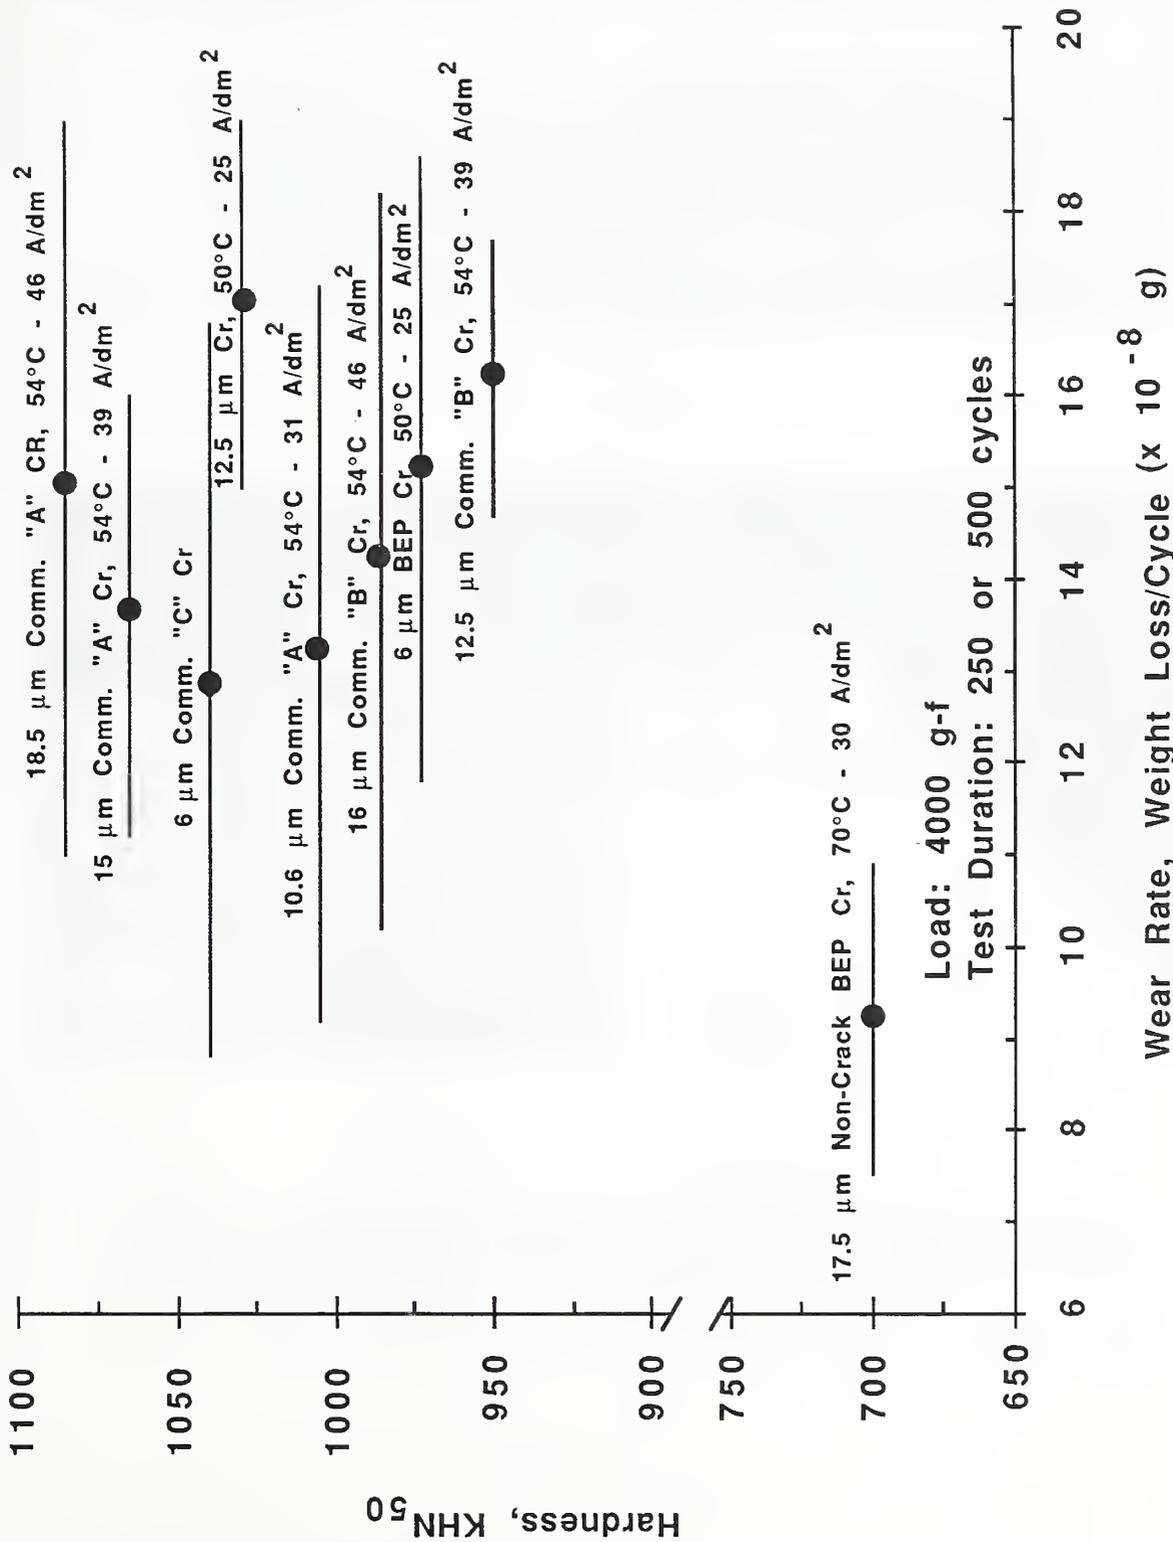
Figure 16. Graph of wear rate and Knoop microhardness of various chromium coatings prepared from the BEP electrolyte and other commercial processes at various operating parameters. The wear results from the accelerated abrasive slurry tester are an average of five tests plus and minus one standard deviation.

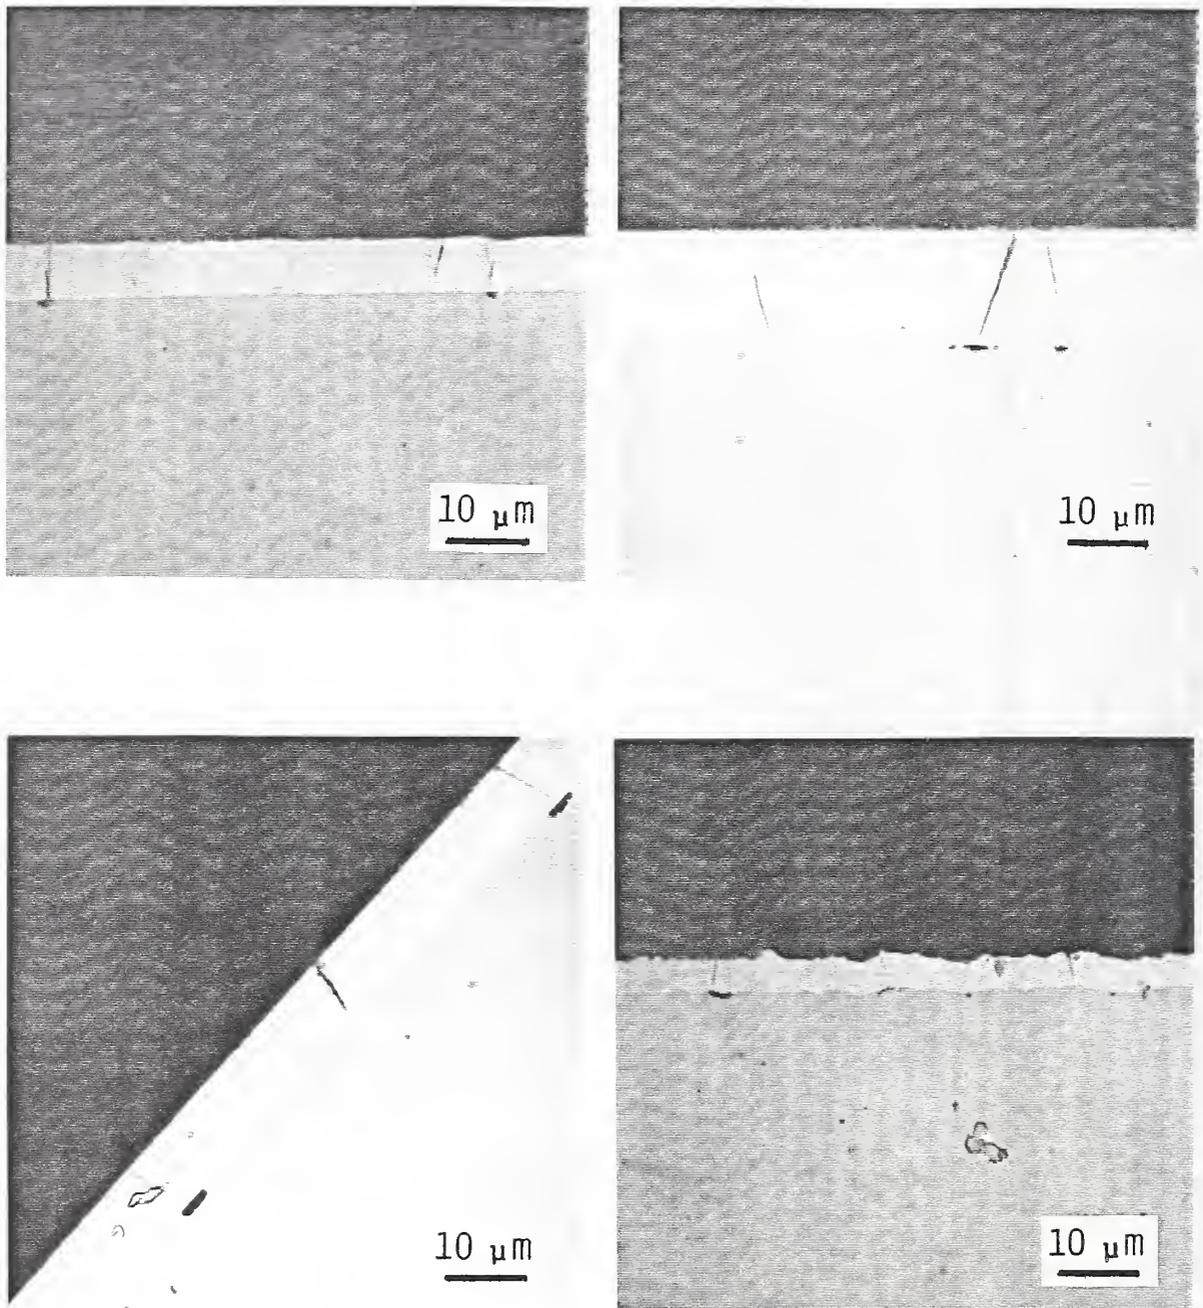
Figure 17. Optical micrographs of polished sections of various chromium coatings on 52100 steel revealing the corrosion of the steel occurring through the microcracks in the chromium coatings after wear testing on the abrasive slurry tester (a) BEP chromium, (b) commercial "A" chromium, (c) commercial "B" chromium, (d) commercial "C" chromium.

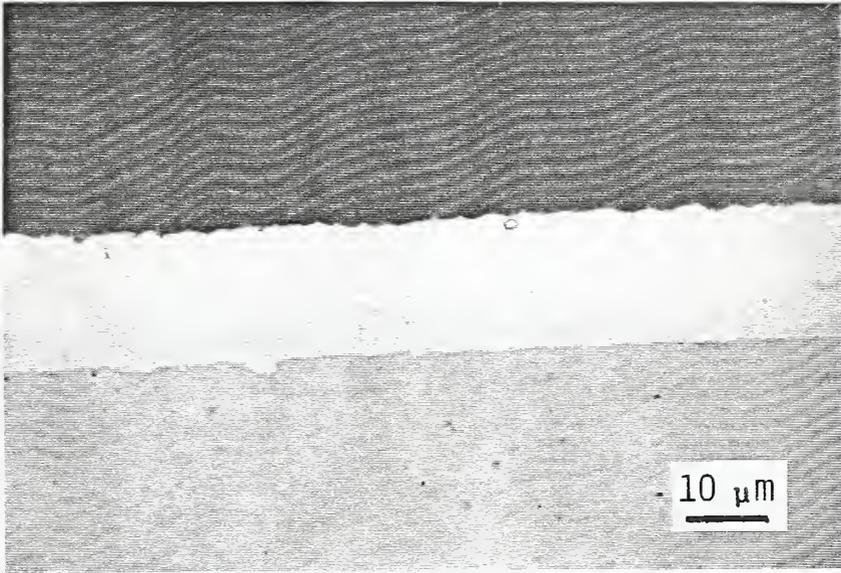
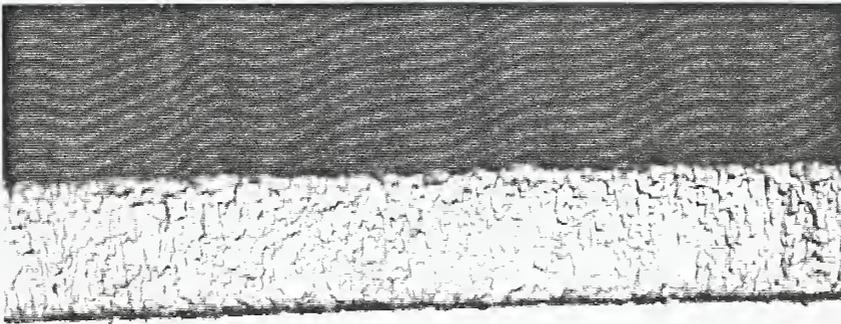
Figure 18. Optical micrographs of a polished and etched section of the non-cracked milky chromium coating on 52100 steel. (a) polished; (b) polished and etched.

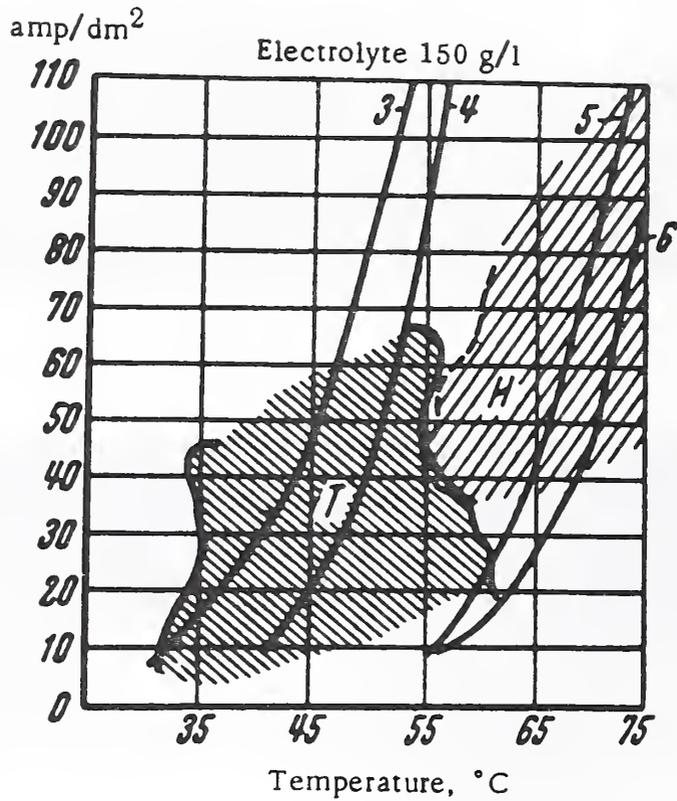
Figure 19. Graph of operating parameters for plating various chromium deposits from a dilute electrolyte. Curves 3 and 4 enclose the zone of transition from gray to bright deposits; curves 5 and 6 enclose the zone of transition from bright to milky deposits.

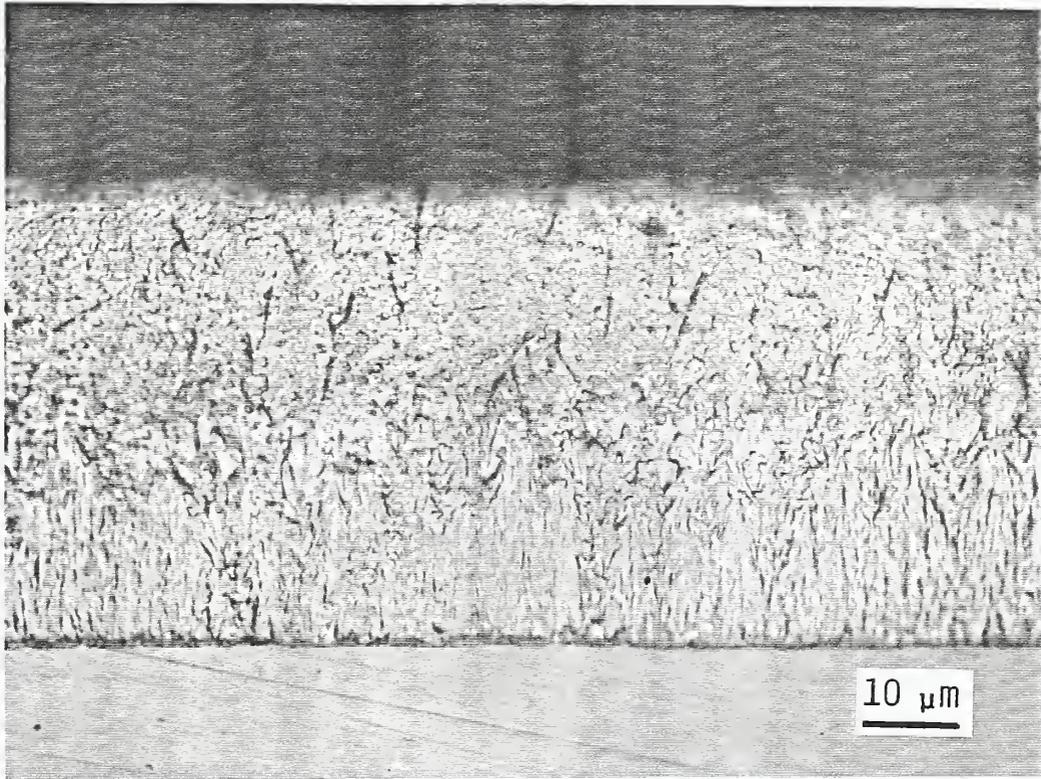
Figure 20. Optical micrograph of an etched section of a DC deposited duplex chromium coating on the nickel. The initial non-cracked layer of this continuous coating was deposited at  $70^{\circ}\text{C}$ ,  $30\text{A}/\text{dm}^2$ . The deposit was etched in a 1:1 hydrochloric-lactic acid solution for 10 seconds.

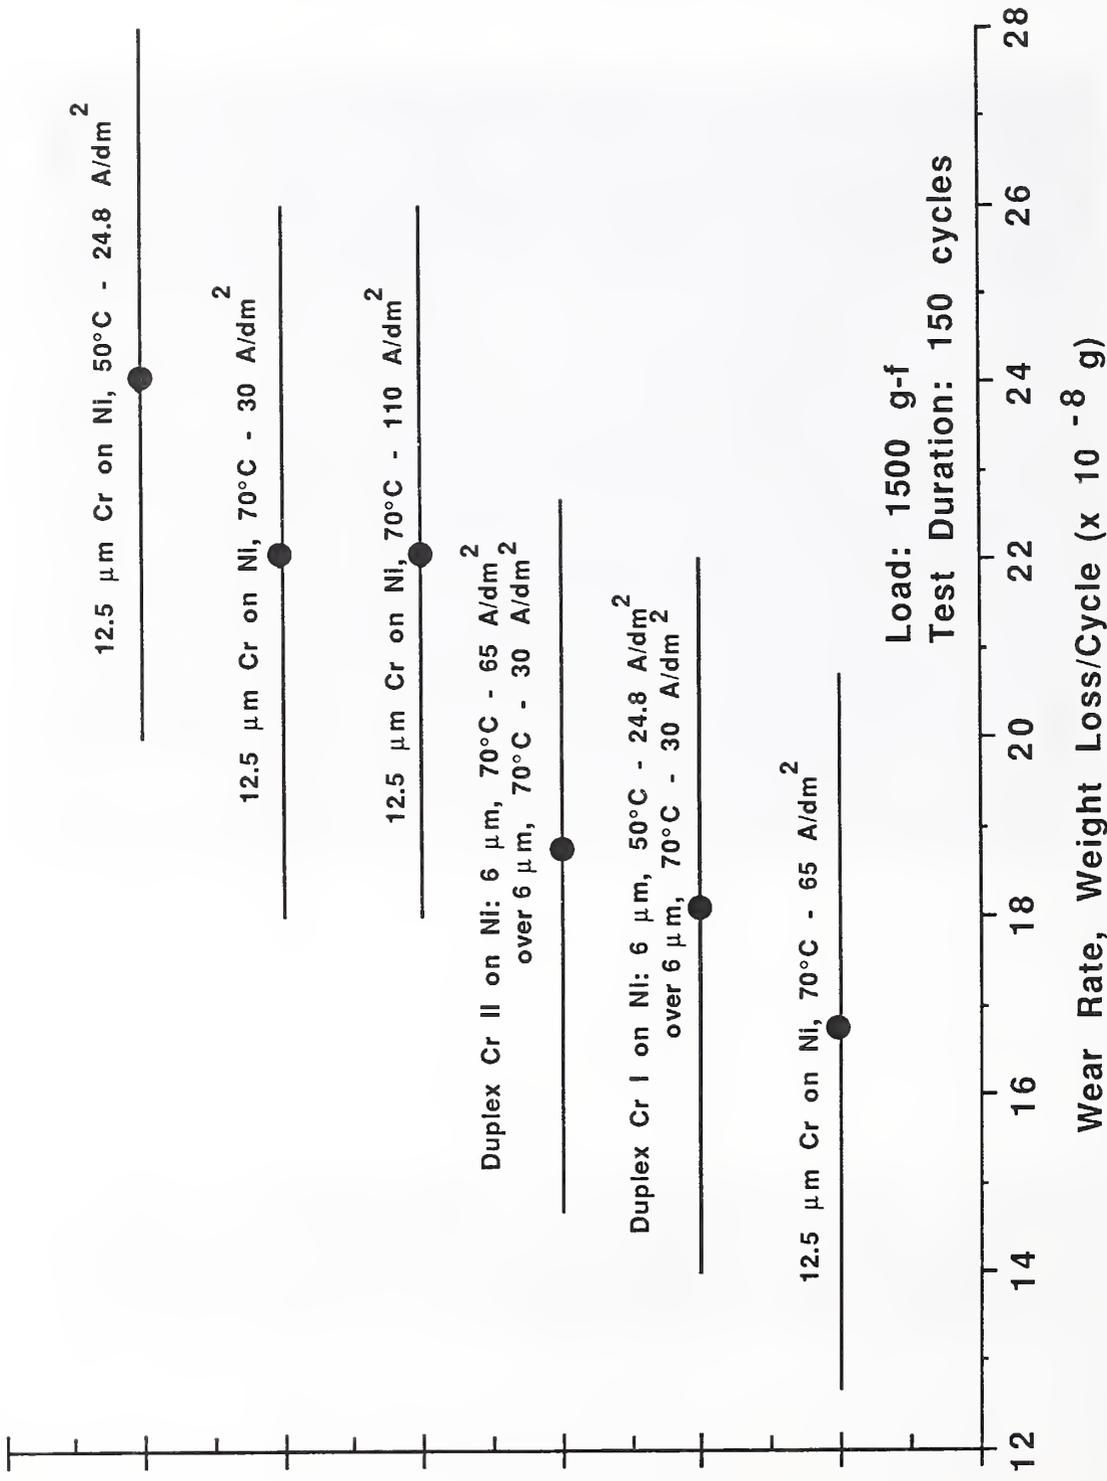
Figure 21. Graph of wear rate for chromium coatings from the BEP electrolyte at various operating parameters. Wear results from the abrasive slurry tester are an average of five tests plus and minus one standard deviation.
